INVESTIGATION OF A CERMET GAS-TURBINE-BLADE MATERIAL

OF TITANIUM CARBIDE INFILTRATED WITH HASTALLOY C

By Charles A. Hoffman

January 24, 1956

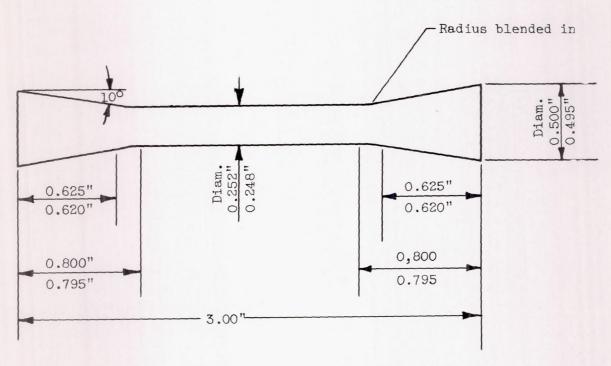
Figure 1. - Cermet specimens.

(a) Stress-rupture specimen.

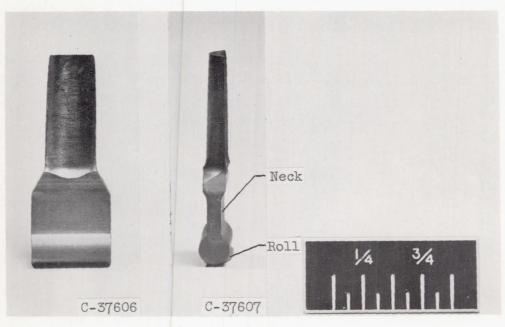
Figure 1. - Concluded. Cermet specimens.

The cermet blade shape used in this investigation (fig. 1(b)) is the same as that used in previous studies of small-scale cermet turbine blades (refs. 3 and 4). The airfoils of the cermet blades and of the alloy control blades (fig. 2) are nominally the same. The roll and the neck of the cermet blade roots were larger than those of the alloy blades.

(b) Blade.

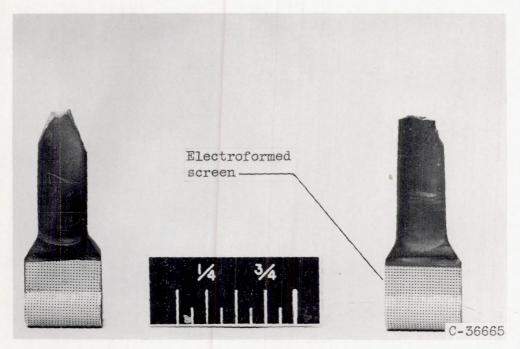
A comparison of the performance of the cermet blades with that of the control alloy blades shows that both types of blade were damaged by impact. Cermet blades 6 and 7 withstood repeated impact (fig. 3) without catastrophic failure. Although the airfoil mass of these blades was reduced by chips removed by impact, the total reduction in mass was not great, and the effect upon blade centrifugal stress was not believed appreciable. The cermet blades, however, tended to undergo catastrophic failure upon impact. The alloy control blades, on the other hand, generally appeared better able to resist impact (fig. 11); these blades were nicked and their edges were torn. This damage, however, was less extensive than that of the cermet blades.

Figure 3. - Impact damage to cermet turbine blades 6 and 7.

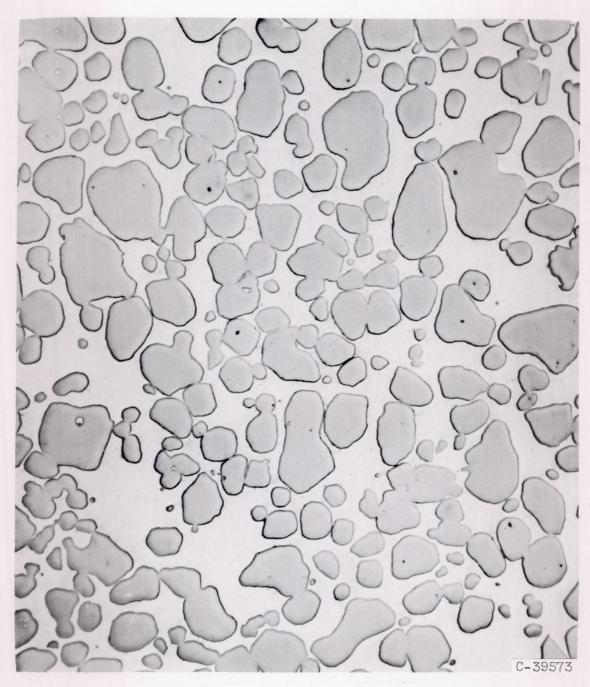
The microstructure of the cermet is shown in figure 4. The metal phase appears to be continuous, and the carbide phase is rounded, that is, spheroidized. Spheroidization of the microstructure has been suggested (ref. 6) as a method of imparting ductility to an otherwise brittle cermet. While the effect of structure on ductility has not been definitely established, reference 1 reports that an infiltrated cermet had higher impact strength than cold-pressed and sintered cermets of other compositions; the improvement is attributed to rounding of the carbide particles and to more even distribution of the carbides in the metal phase. The observed structure might also explain why blades of the present material appeared to be comparatively free of sensitivity to stress concentration, which will be discussed subsequently.

Figure 4. - Titanium carbide infiltrated with Hastalloy C. Unetched; X1000.

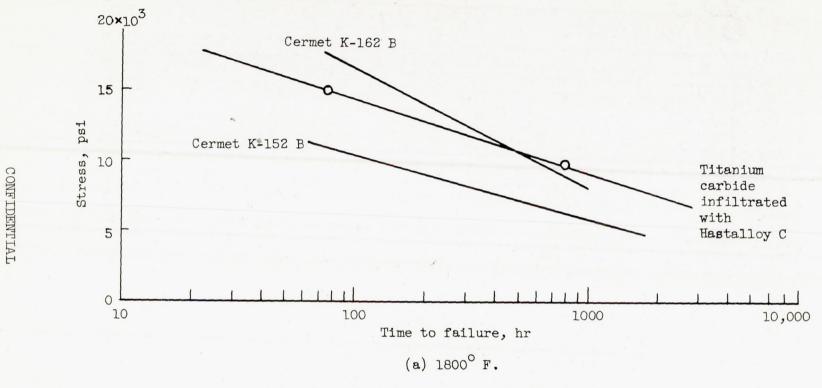
Figure 5. - Comparative stress-rupture strengths.

Results of the stress-rupture study are presented in figure 5. Failure of the cermet specimens generally occurred at the fillet between the conical portion and the cylindrical portion. This location of failure indicates that the observed stress-rupture values are lower than they might have been if failure had occurred toward the center of the specimen. The reason that failure occurred at the fillet is not clear. The occurrence of stress concentration effects in the tensile specimens is inconsistent with the blade results. Although two of the specimens showed severe oxidation (perhaps due to segregation) in small areas of the test bars, the remainder of the specimens were not appreciably attacked in the temperature range of 1600° to 1800° F.

Stress-rupture data at 1800° F for the test cermet are presented in figure 5(a); data for two other currently interesting materials are included to indicate the relative strength of this composition. Despite the higher metal content of the test cermet (50 percent by weight compared with 30 percent by weight for the other compositions), the strengths of the three materials were quite similar.

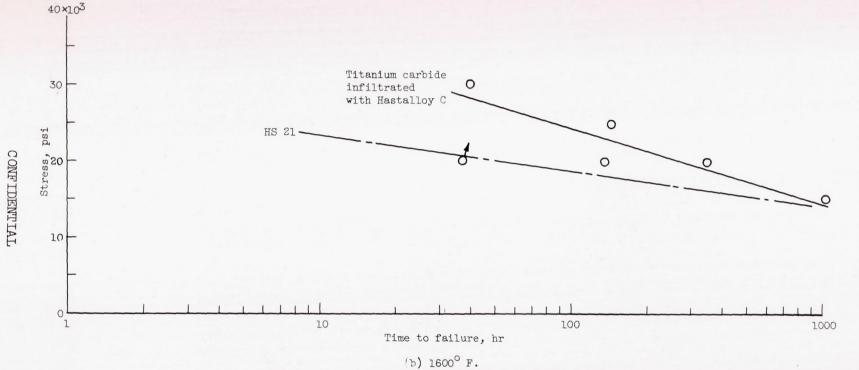
Figure 5. - Concluded. Comparative stress-rupture strengths.

The 1600° F stress-rupture strengths for the infiltrated cermet and for the HS-21 control alloy are presented in figure 5(b). On the basis of these data alone, blades of the cermet would be expected to have longer lives than blades of this alloy.

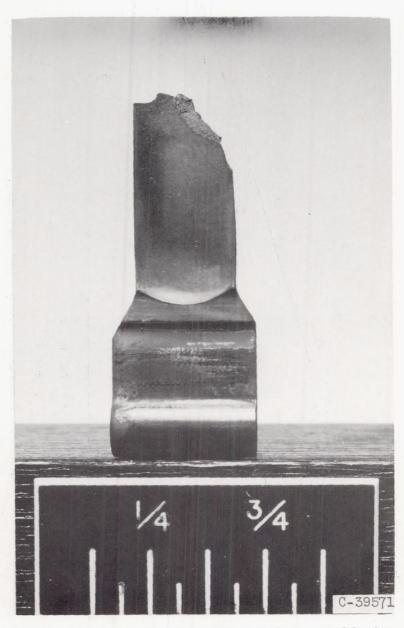
Description of failures. - A summary of engine operation is presented in table I. The simultaneous occurrence of a nearby wheel dovetail failure in the case of blade 1 and the appearance of blades 2 and 4 after failure indicate that these three failures were caused by impact. The failure in the base of blade 1 occurred completely across the neck just above the neck-roll juncture. The airfoil failure due to impact of blade 2 is shown in figure 6. This failure is similar in appearance to that of blade 4.

Figure 6. - Cermet turbine blade 2 after failure caused by impact.

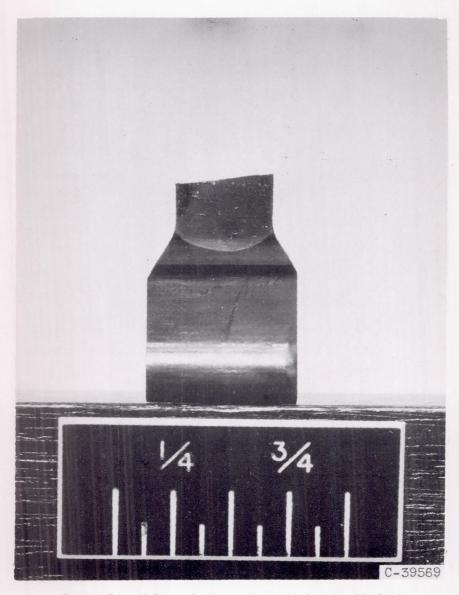
Blades 6 (fig. 7) and 7 failed at about midspan along with the failure of several short metal blades. Previous experience with alloy blades indicates that the failure of the airfoil of either cermet blade would not be expected to set up sufficient vibration to cause the failure of metal blades. Hence, it appears likely that the alloy blades failed first and caused cermet blade failure by impact or excessive vibration. In the case of blade 7, the possibility that failure occurred by impact was strenghtened by the observation that the blade was chipped (fig. 8). In either blade, there is also the possibility of failure due to normal stresses.

Figure 7. - Midspan failure of cermet turbine blade 6.

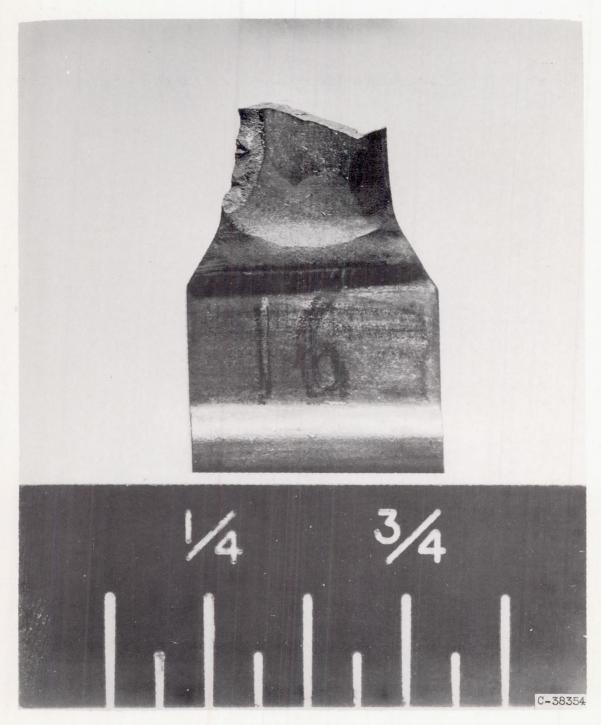
Figure 8. - Cermet blade 7, which may have failed by impact.

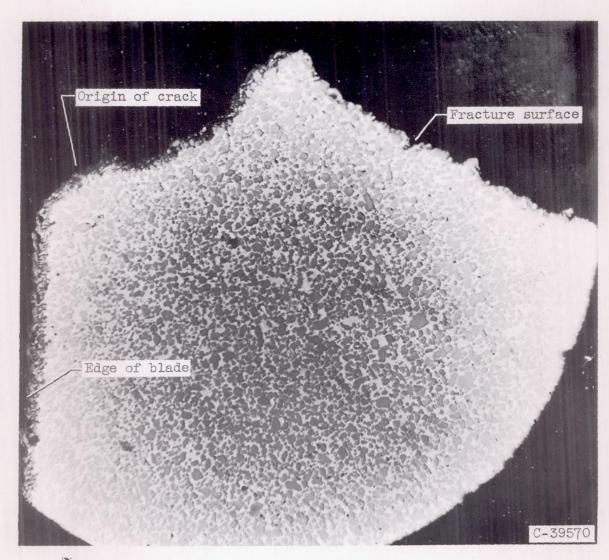
Blade 3 also failed in the airfoil section. Study of a photomicrograph of the edge of the fracture of this blade (fig. 9) revealed an oxide layer, of which the initial portion was about the same thickness as the exterior surface oxide layer. This observation suggests that a surface flaw had been present and had caused failure of this blade. The surface-finishing procedures, mentioned previously, were used on blades 4 to 7 and were intended to eliminate such flaws.

Figure 9. - Oxidation of surface crack of cermet blade 3. X150.

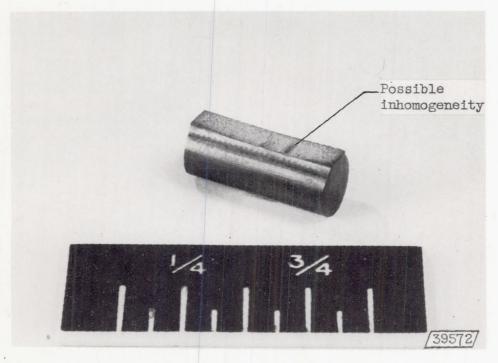
The failure of cermet blade 5 in the base at the juncture of the neck and the roll (fig. 10) in a manner similar to the failures in blades of other cermet compositions (refs. 3 and 5) may have been due to stress concentration effects. The unusually short time to failure suggested that this blade might have also failed as a result of a structural flaw. Inspection of the failure revealed a possible zone of inhomogeneity.

Figure 10. - Failure of cermet blade 5 at juncture of neck and roll.

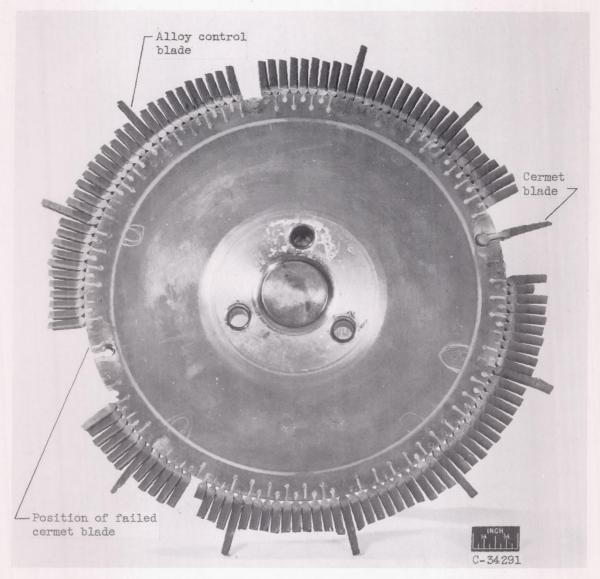
Figure 11. - Rear view of wheel 1 after failure of cermet blade 3.
